Role of computed tomography in determining the choice of treatment for delayed ceramic acetabular liner fracture: A case report

Ferdi Dirvar

Department of Orthopedics and Traumatology, Metin Sabancı Baltalımanı Bone Diseases Training and Research Hospital, Istanbul, Turkey

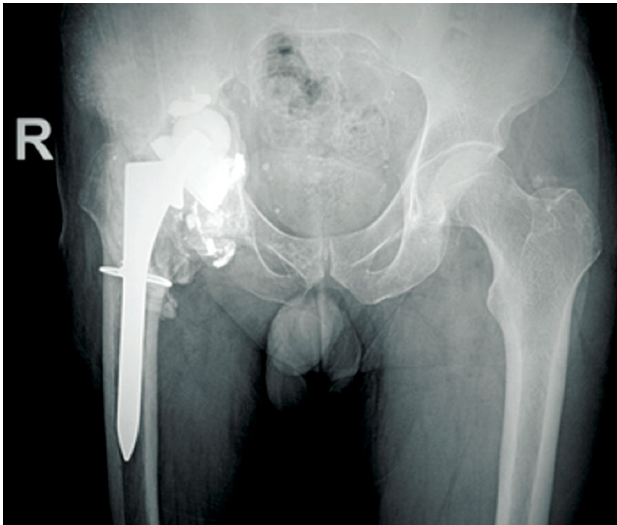
A 50-year-old male patient was admitted with complaint of pain at the right hip and also limb length shortening. A total right hip prosthesis had been applied in 2012 in another medical center. Patient had a traumatic event in 2014 and after examination and a proper X-ray imaging, acetabular liner fracture was diagnosed. Patient refused the choice of revision hip arthroplasty and continued full weight bearing for three years. In 2017, the patient was accepted to our hospital whose pelvis anteroposterior X-ray visualized a catastrophic acetabular component failure (Figure 1). A written informed consent was obtained from the patient.

FIGURE 1. A 50-year-old male patient with untreated acetabular liner fracture. On pelvis anteroposterior radiograph, catastrophic failure of acetabular component can be observed.

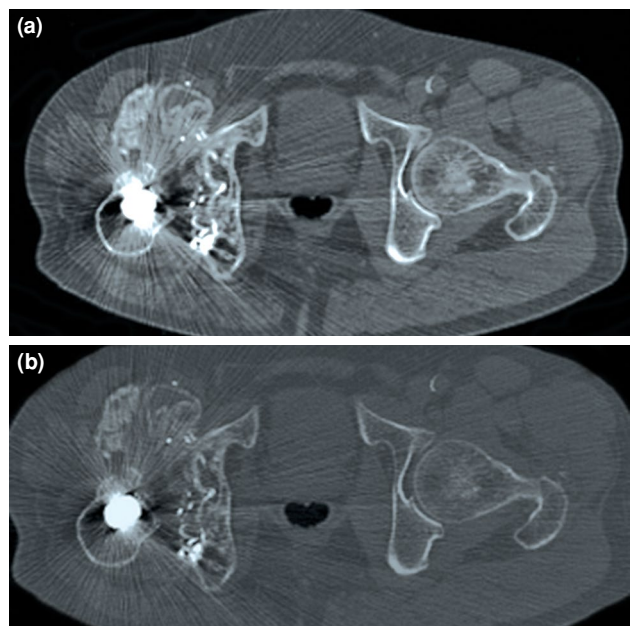
FIGURE 3. (a) Amorphous high-density sites can be observed on rectus femoris muscle's proximal portion and hip joint space in axial views. (b) After application of whiting out technique, ceramic fragments can be seen more clearly on computed tomography image.
